## Snap-Tite® Culvert Lining System

## The no-dig trenchless solution.

The Snap-Tite® HDPE Lining System is ideal for failing metal and concrete culverts.

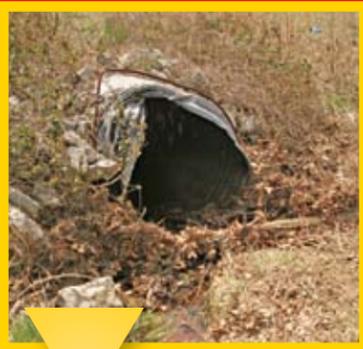
A typical deteriorated culvert close to failure, potentially leading to road collapse and danger to the motoring public.

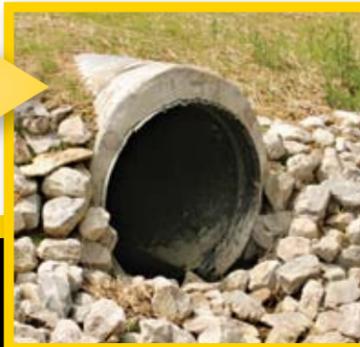
The totally rehabbed Snap-Tite® culvert. Nearly all the work was completed off-road in the culvert itself. No road closure or traffic interruption occurred.

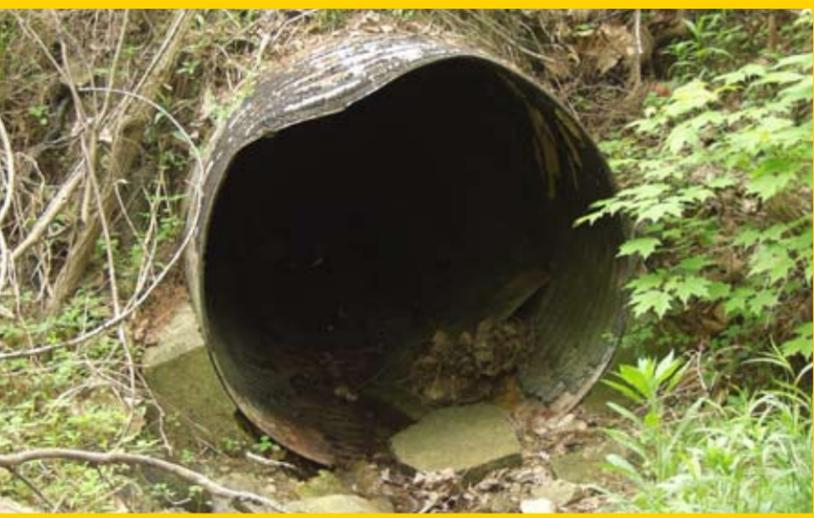
State Departments of Transportation, counties and municipalities are facing a critical problem. Culverts installed forty to fifty years ago are failing at an alarming rate nationwide. Thousands of corrugated metal culverts are so significantly rusted that a danger of sink holes, road collapse or flooding exists. Concrete culverts have cracked or pulled apart at the joints, creating similar dangerous scenarios. Conventional repair methods of the past have been to dig and replace the failed pipe. There is now a dash to find a solution that is economically feasible, quick, and avoids road closures and detours for the motoring public.

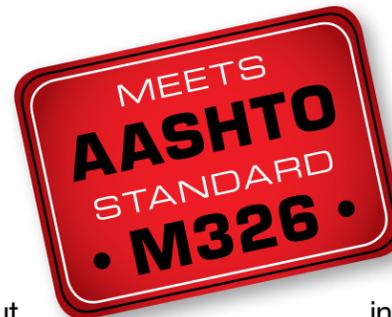
Snap-Tite's® patented male/female machining at each end of the HDPE allows it to be 'snapped' together, piece by piece, and pushed into the full length of the existing pipe. It is available in lengths from 2 feet to 50 feet long, and is available for existing culverts with diameters from 8 inches

to 84 inches. Unlike other so-called 'rehab systems,' the annular space between the host pipe and the new Snap-Tite® pipe is filled with a low density cellular grout, which fills in any voids between the roadway and culvert, delivering a truly 'rehabbed' culvert.
